# **GEOLOGIA: ORIGEM E TRANSFORMAÇÃO**

**Abstract:** The purpose of this study was to map the sites aimed at the occurrences of lateritic or duricrust on the island of São Luis in the state of Maranhão – Brazil. The island comprises typical landscape features such as vegetation, water courses, exposed soils, urban areas, agricultural areas and pastures. The mapping methodology focused on the Crosta Technique applied to six and four spectral bands of the TM Landsat 5 sensor. The results show that the application of the four-band technique is more efficient in detecting iron oxide/hydroxide minerals. Many of the potential areas of occurrence of mapped iron oxide/hydroxide minerals correspond to the ceramic roofs of buildings, and possibly to concrete surfaces, which have a spectral behavior similar to that of iron-rich surfaces in the reflected infrared range. Many studies on lateritic rocks are also developed at African and Indian universities applied to civil engineering and precisely aiming at the use of lateritic rocks as construction material for multiple purposes. The present study was obtained based on the analysis of remote sensing mapping. The methodology focused on the Cro

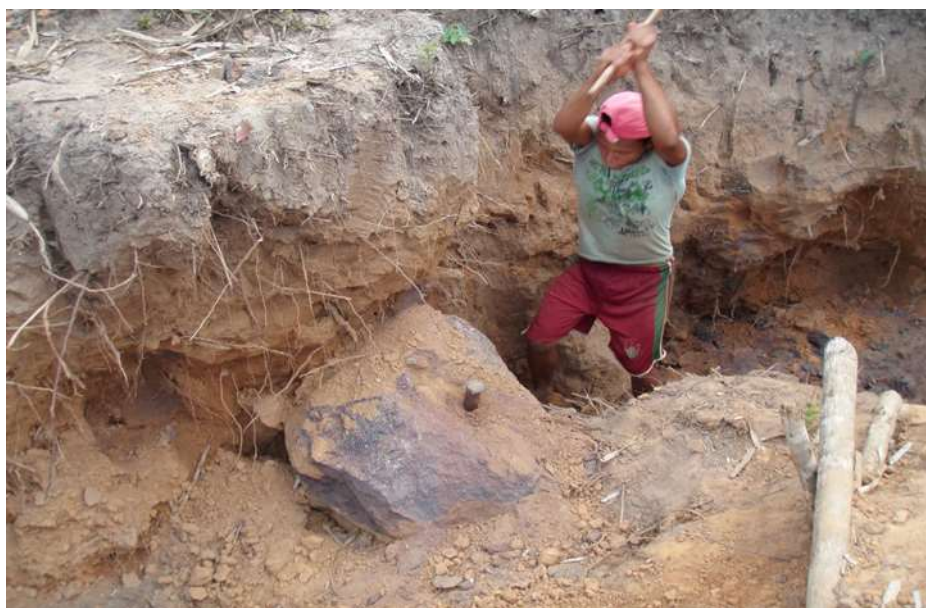
**Figure 2.** Lateritic coverage with variable thickness of 0.50 to 1.50 m. The image belongs to deposit/point 19.

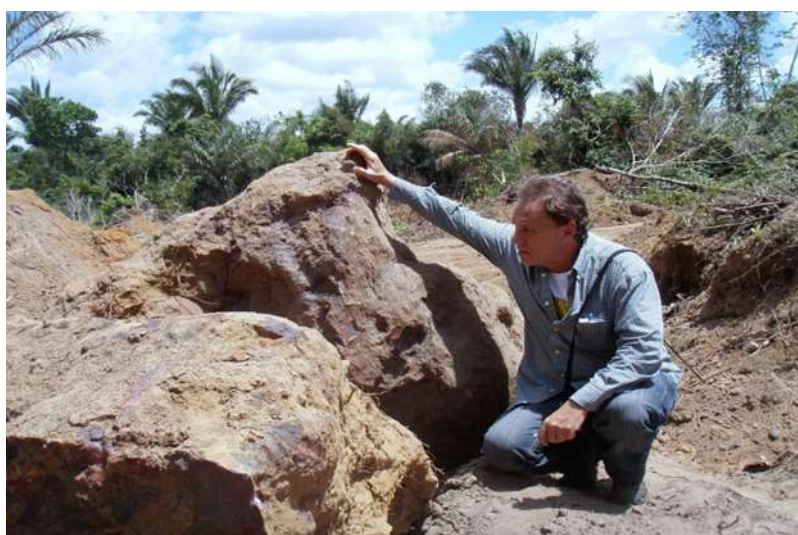
**Figure 3.** Detail of the stone material extracted from the "duricrust" laterite deposit. The image belongs to deposit/point 19.

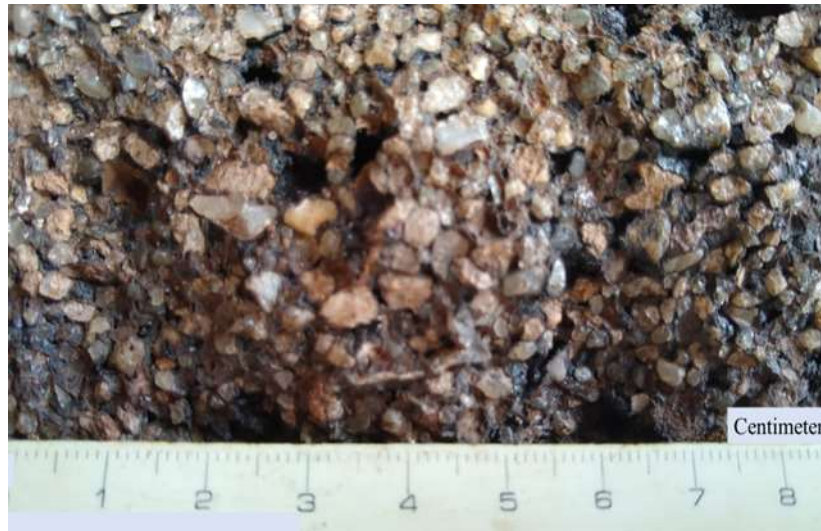
**Figure 4.** Detail of the structure of the laterite in the “Maracujá Deposit” (point 19 in Figure 1), showing the proportionality between the quartz-rich matrix and the ferruginous cement. The cement has the following chemical composition determined by X-Ray fluorescence: %  $\text{Al}_2\text{O}_3$  - 2.4, %  $\text{SiO}_2$  - 8.0, %  $\text{P}_2\text{O}_5$  - 1.6, %  $\text{Fe}_2\text{O}_3$  - 76.5, %  $\text{CaO}$  - 0.10, % PPC – 11.1.

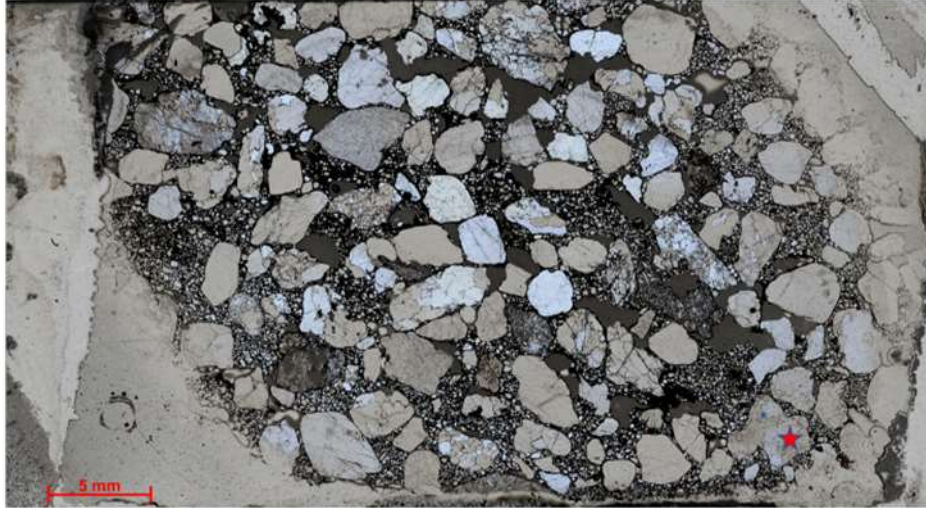
**Figure 6.** Photomicrograph referring to the lateritic ferruginous conglomerate with microscopic aspects obtained in light with parallel polarizers evidencing the interaction between the cementitious ferruginous oxides with the quartz matrix. Note that ferruginous cement encompasses very fine particles of quartz fractions. Detail of the red star in Figure 7.

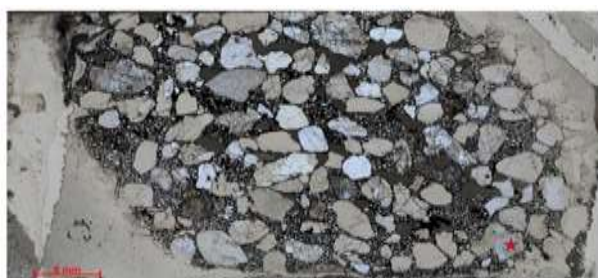
**Figure 11** - Photomicrograph referring to the lateritic ferruginous conglomerate with microscopic aspects obtained in light with parallel polarizers evidencing the interaction between the cementitious ferruginous oxides with the quartz matrix. Note that ferruginous cement encompasses very fine particles of quartz fractions. Detail of the red star in Fig.12.

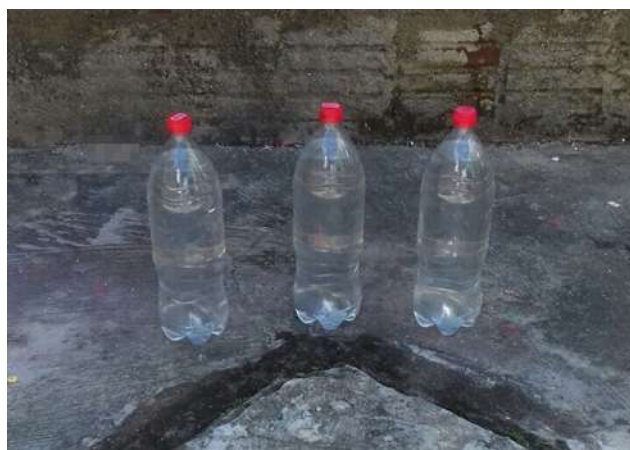
**Figura 1-** Amostras de água suspeita

Foram coletadas amostras de água suspeita de três poços freáticos, de acordo com a ABNT NBR 15900-2/2009, a fim de realizar a análise físico-química da água e os ensaios de resistência à compressão simples de argamassas. Os recipientes utilizados para a coleta foram garrafas plásticas, mas especificamente garrafas de Polietileno Tereftalato (PET) de 2 litros de capacidade, com tampa e perfeitamente limpas e enxaguadas com a mesma água que cada uma iria armazenar, como é apresentado na Figura 1.

Em se tratando de águas subterrâneas, as amostras foram coletadas com o auxílio de bomba e somente após o fluxo de água que permitia a lavagem completa dos dutos.

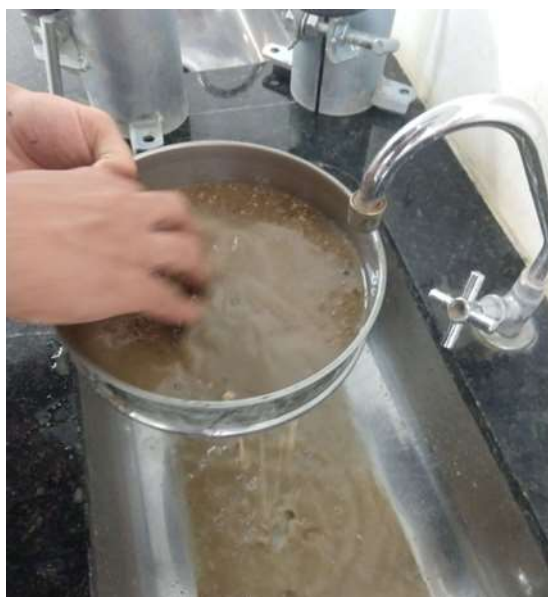
**Figura 3** - Lavagem da areia

A areia adquirida possuía cor escuro-avermelhada evidenciando que não se tratava de uma areia de rio, podendo ter sido obtida de cava ou barranco e assim possuir impurezas, como por exemplo, excesso de partículas finas (argila e silte) que podem causar danos à qualidade da argamassa. Por consequência, foi adotado o procedimento de lavagem da areia, onde se fez uso de uma peneira de abertura de 0,075 mm e água corrente para remoção de boa parte das impurezas, conforme apresenta a Figura 3.

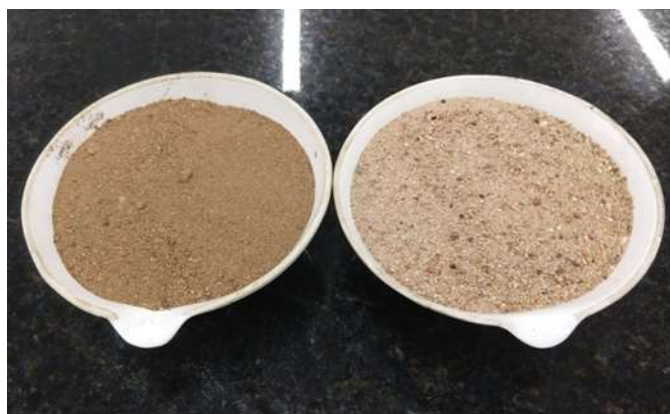
**Figura 4** - Comparação da cor entre a areia lavada e a areia natural

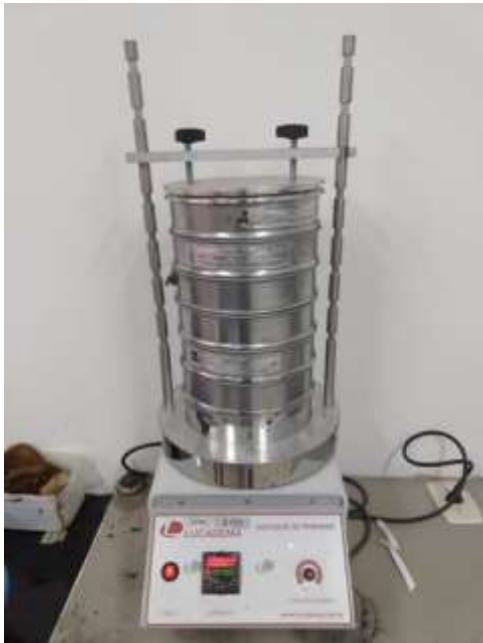
**Figura 5** - Peneiramento da areia para caracterização

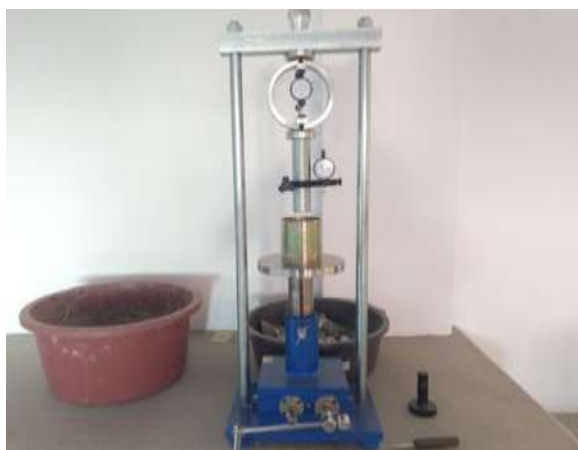
Figura 7 - Rompimento dos corpos de prova
